Do Hail-Caused Dents “Damage” Steel Roof Panels?

1st Edition

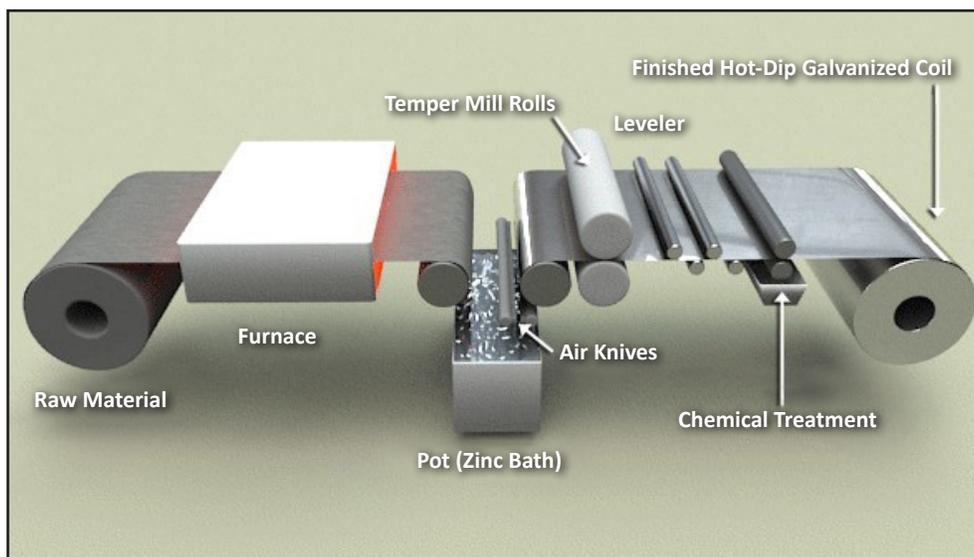
Galvanized or Galvalume® steel roof panels start as steel coils that are dipped in a zinc-based coating. This process is known as “Continuous Sheet Galvanizing” or “Coil to Coil Galvanizing”. After the galvanizing process, the steel is coiled up and shipped to manufacturers for forming, or coaters for an application of a colored coating. Some contractors will purchase coils of the galvanized or painted steel for on-site manufacturing. An illustration of the steel coil coating process is depicted below.

Figure 1 – Steel Coating Process. Illustration by Steel Dynamics.
<http://www.steeldynamics.com/The-Techs/Products/Process-Overview.aspx>
